Dusts and Residues from Machining and Incinerating Graphite/Epoxy Composites
A Preliminary Study

EPA-600/2-79-196
November 1979

Dusts and Residues from Machining and Incinerating Graphite/Epoxy Composites

A Preliminary Study

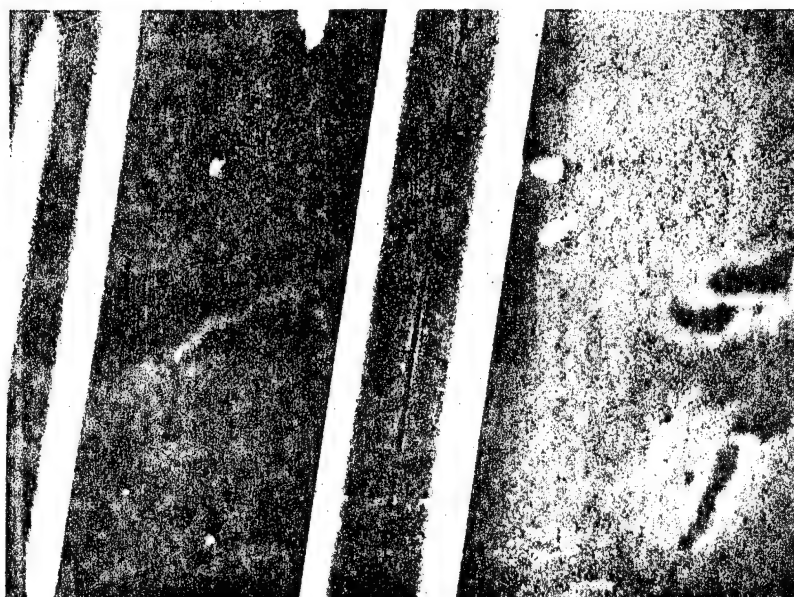
Fig. 1 SEM micrographs of carbon fiber samples:
(a) Panex 1/4 CF (Stackpole); (b) Magnamite
AS3 (Hercules).

Scanning electron micrographs of typical carbon fiber production samples are shown in Figure 1. The fibers appear to be smooth circular cylinders with diameters varying from about 5 to 8 μm , though the actual cross-sectional morphology of different samples vary and include circular, elliptical and dogbone shapes. Some manufacturers expose fiber surfaces to a roughing etch to improve interlaminar shear strength in the composite. Also, a sizing or coating of resin is often added to enhance the bonding capability of the fibers in the composite medium.

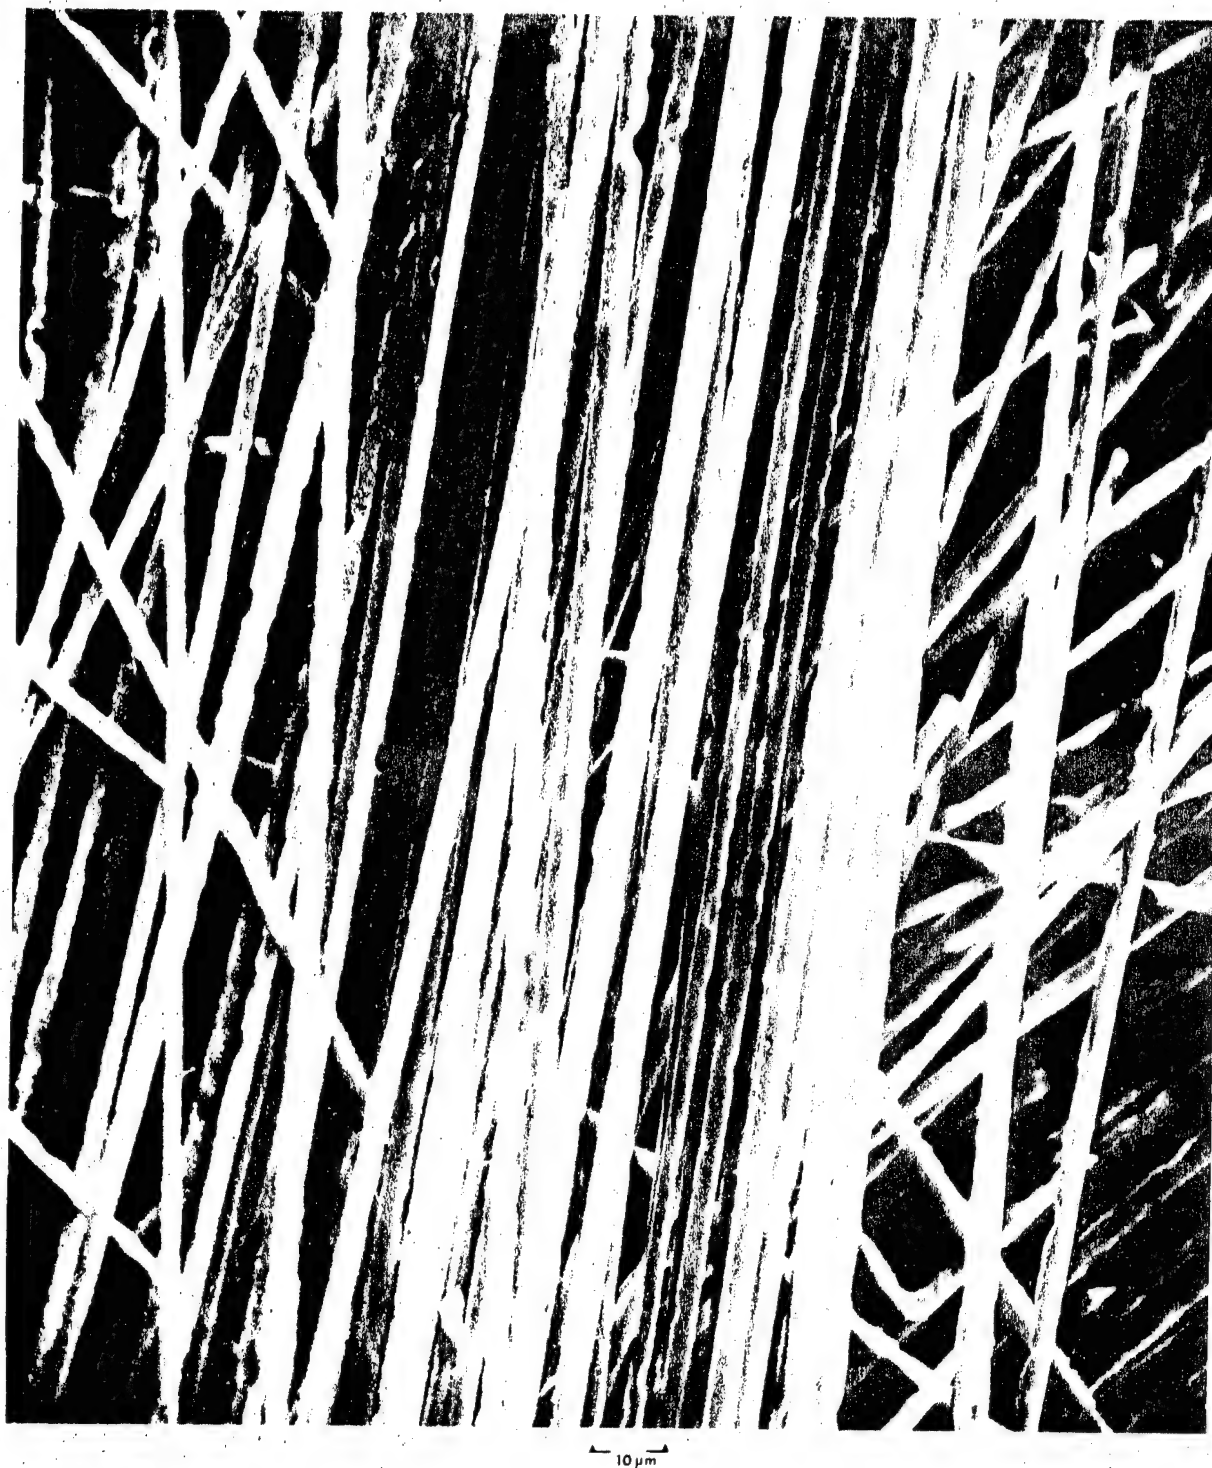
Fig. 5 SEM micrograph of carbon fibers [Thornel 300 (Union Carbide)] after exposure for 3.5 minutes at 1000°C.

Exposure of raw carbon fiber samples to temperatures of 200° to 220° C for 30 to 60 minutes caused little or no damage. As shown in Figure 3, there were no discernible changes in the appearance of the fibers when observed in the SEM. At a temperature of 1000° C, however, the fibers showed definite signs of degradation after a short period. Dimples or pits in the fibers appeared after 1 minute (Figure 4) and were deep and numerous after 3 1/2 minutes (Figure 5). A general thinning of the fibers even in undimpled portions was also noted.

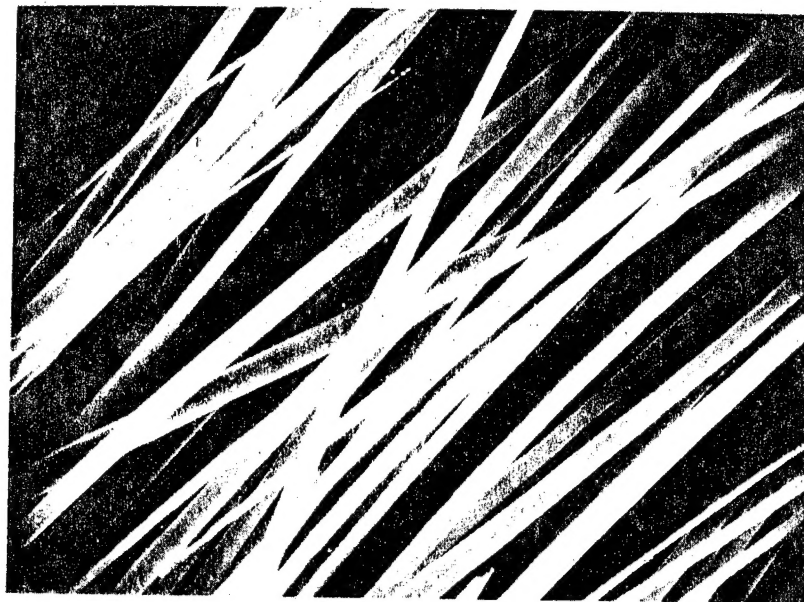
Fig. 8 Woven cloth sample [Panex PWB-6 (Stackpole)] after exposure for 23 minutes at 1000°C: SEM micrographs at two different magnifications.

Another type of carbon fiber product subjected to incineration was a woven cloth (Panex PWB-6 manufactured by Stackpole) designed for high heat resistance. After exposure for 23 minutes at 1000° C, the cloth fibers were still in remarkably good condition (Figure 8) though showing very definite signs of damage including thinning and pitting.
